Manhole Inspection Summary

Manhole # S31KK1019MH

Insp Date: **2/22/07 1:12 PM**

Location Address: **4311 RUGBY RD**

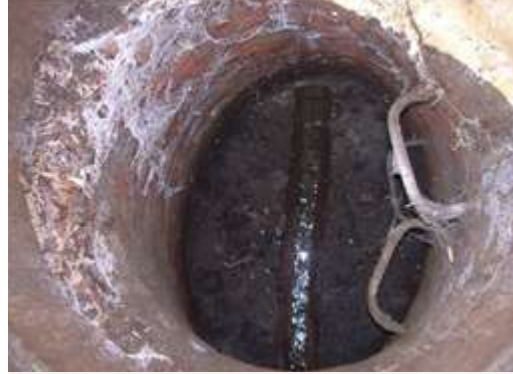
Top View

Evidence of surcharge - Bench debris.

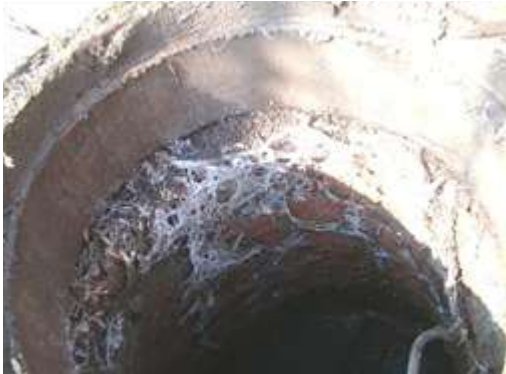
Defect

Frame leaks. Frame offset. Adjustment deterioration, root intrusion and infiltration. Corbel root intrusion and infiltration.

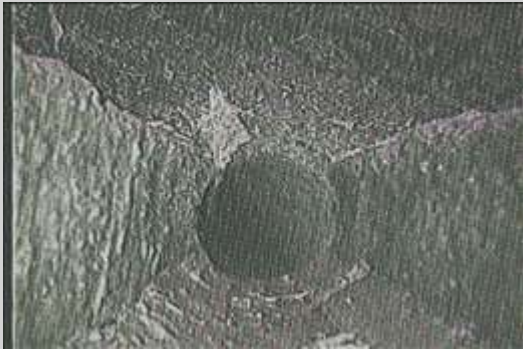
6 in. Circular Gravity Sewer Pipe Out @ 12 O'Clock

Barrel deterioration, root intrusion and infiltration.

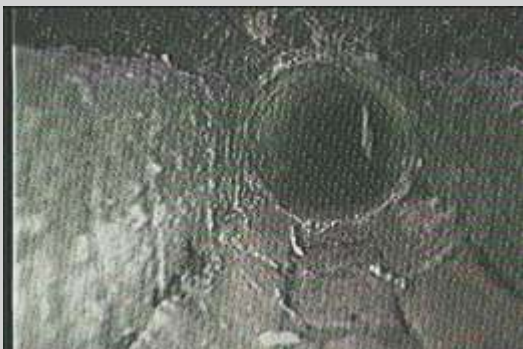
6 in. Circular Gravity Sewer Pipe In @ 6 O'Clock

Channel deterioration.
